Manhole Inspection Summary

Manhole # S19W__009MH

Insp Date: **7/1/08 9:29 AM**

Location Address: **2322 james st**

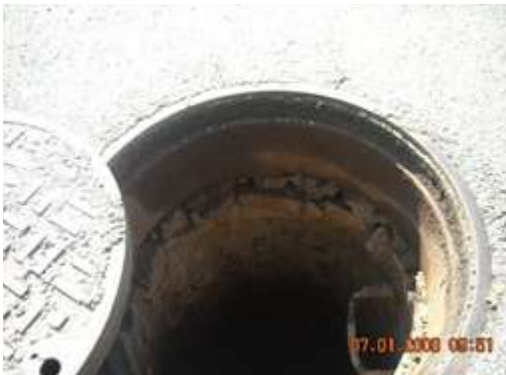
Misc

inflow evidence from sheeting

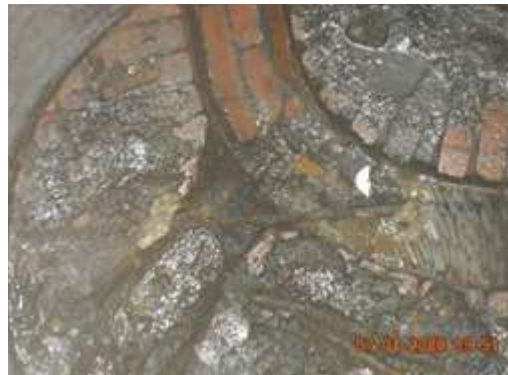
Defect 6

Condition: ☐ Sound ☐ Cracked ☐ Root Intrusion ☐ Deteriorated ☐ Leaks ☒ **Debris**

debris in channel

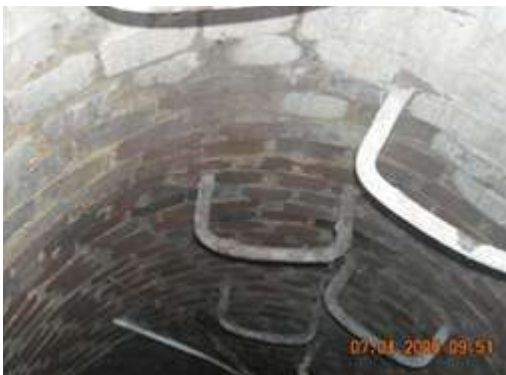
Defect 5

Infiltration: ☐ None ☐ Joint ☐ Cracks ☐ Mortar ☐ Roots ☒ **Wall**

infiltration @ corbel wall

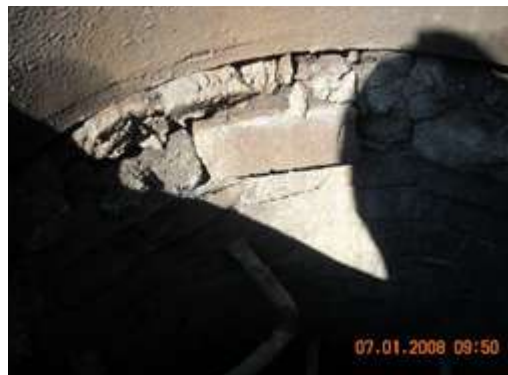
Defect 3

Condition: ☐ Sound ☐ Cracked ☐ Root Intrusion ☒ **Loose Brick** ☒ **Deteriorated**

loose chimney brick

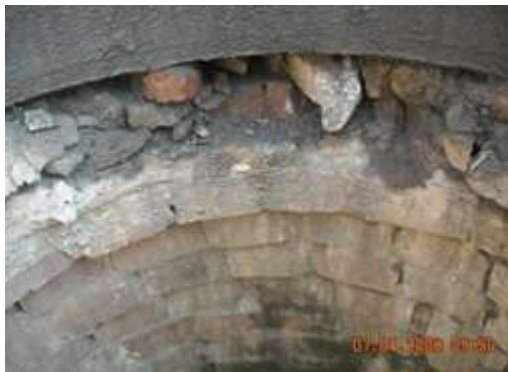
Defect 2

deteriorated chimney

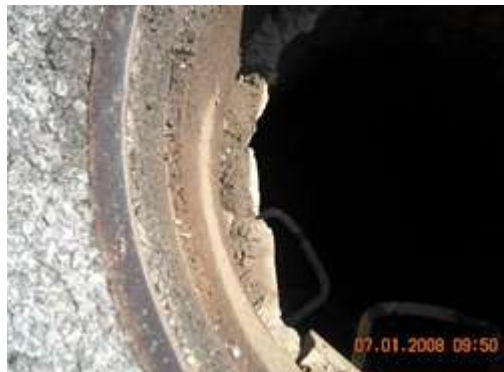
Defect 1

Frame Offset: **1** (in.) Condition: ☒ Sound ☐ Cracked ☐ Leaks

frame offset

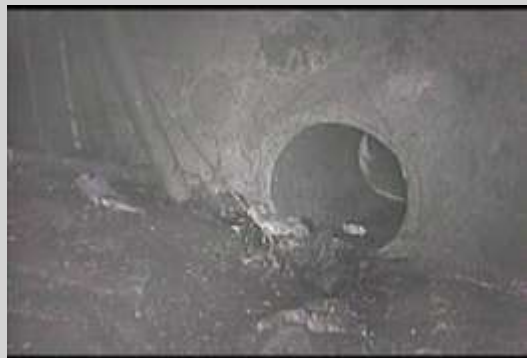
8 O'Clock Inflow

Deposits: ☐ None ☐ Mud ☒ **Sludge** ☐ Debris ☐ Grease

Silt Depth: **1** (in.) Deposits Extent: **Light**
